Drum Hill Walk Audit Lowell & Chelmsford, MA

July 19, 2019

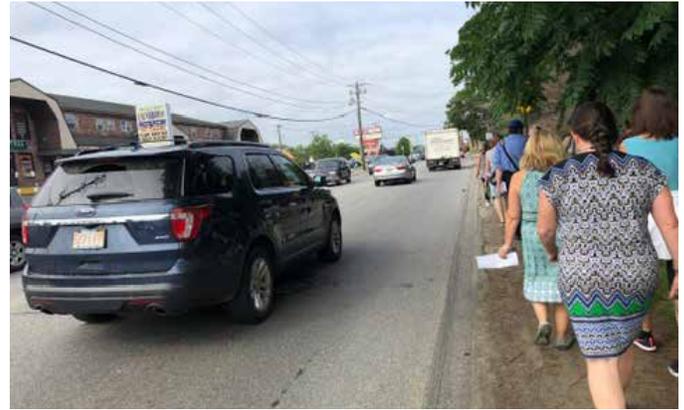
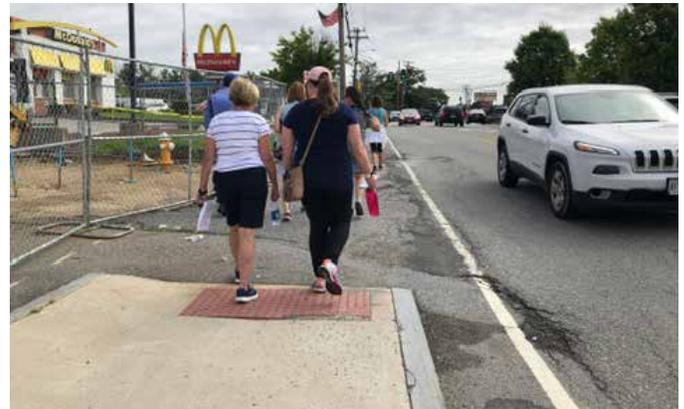
The sidewalk network on Drum Hill Road/Westford Street is not paved in sections and lacks a verge.

- Repair the WALK sign and WALK countdown pedestrian signal at the crosswalk in front of the Walmart retail plaza entrance.
- Update pedestrian signage to the current MUTCD (Manual on Uniform Traffic Control Devices) standards, where needed. Existing signage is dated.
- Install uninterrupted sidewalks on both sides of Westford Street/Drum Hill Road. If the city-owned right-of-way allows, widen sidewalk to at least 5', allow for a verge to separate the sidewalk from the curb-line, and consider planting trees along the street.

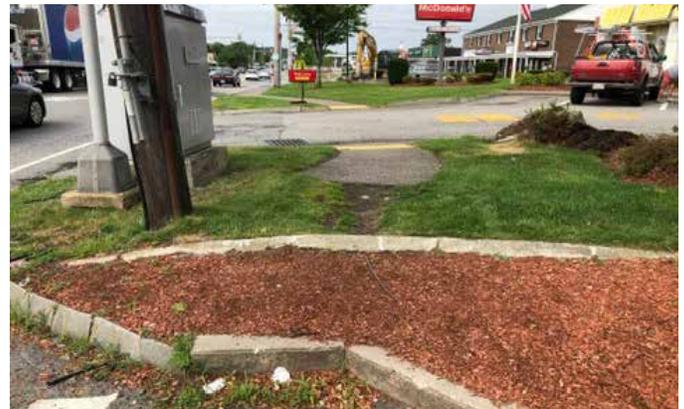
On Drum Hill Road/Westford Street, the sidewalk is frequently interrupted at property boundaries.

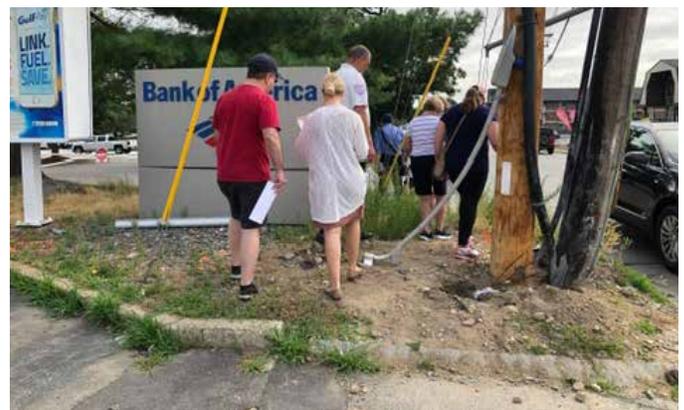
Pedestrians have to navigate cables, rubble, and vegetation along Drum Hill Road/Westford Street at a property line.

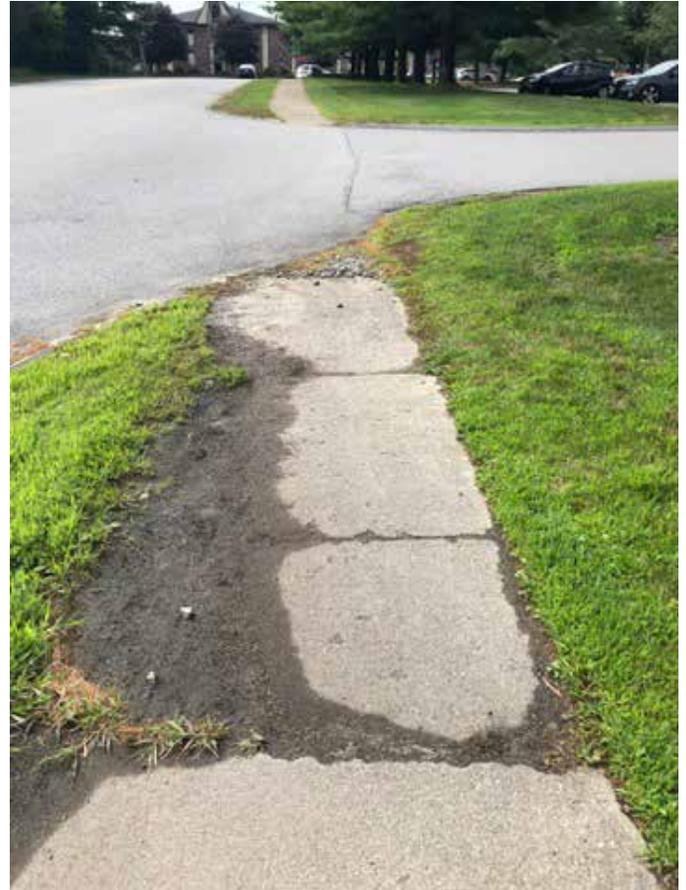
Sidewalks along Technology Drive are generally in good condition, but some maintenance is required.

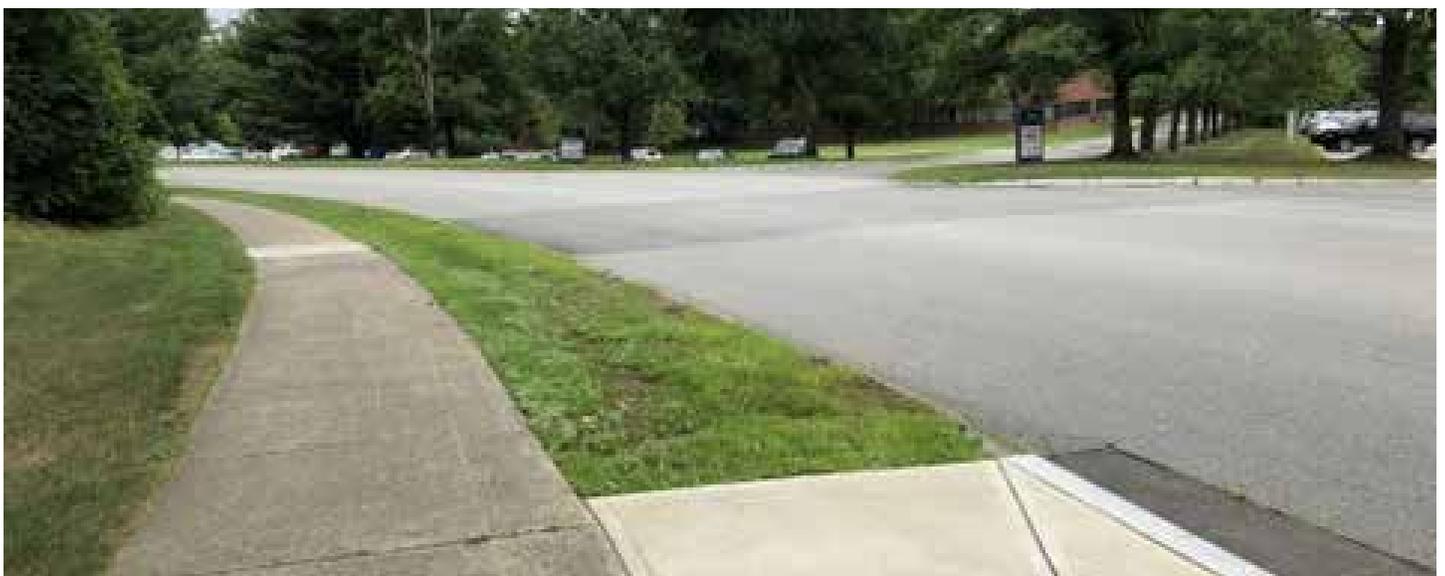
Walk audit participants discussed the need for a raised crosswalk with enhanced pavement markings across from 55 Technology Drive to help reduce traffic speeds.

- Install raised crossing at 55 Technology Drive to help reduce traffic speeds.

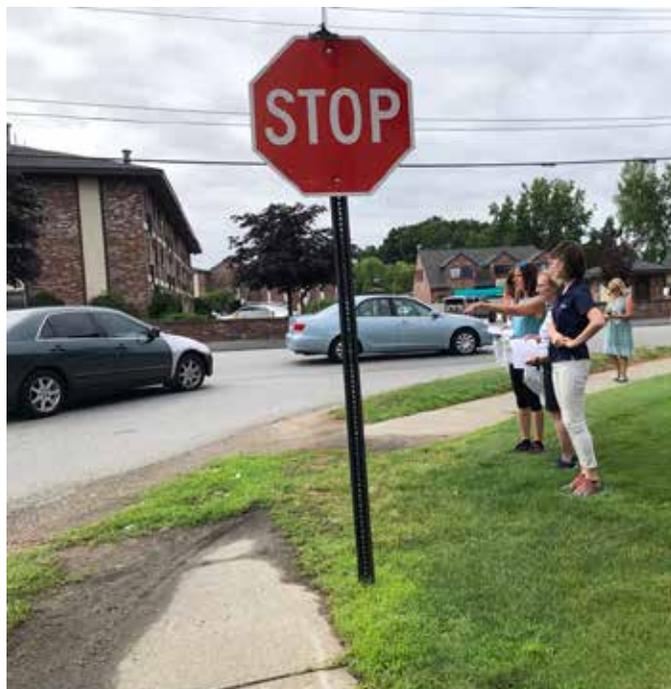
The intersection of Technology Drive and Drum Hill Road/Westford Street is wide with long, sweeping curb radii on both corners of the intersection. The sidewalk at this intersection dissolves along the west side, making it difficult for those with mobility challenges to use the sidewalk. A high stone wall demarcating the entrance to Technology Park blocks pedestrian visibility and leads to cars blocking the crosswalk on Technology Drive as they wait to turn.

The sidewalk at the intersection of Technology Drive and Drum Hill Road/Westford Street is discontinuous.

- Repaint the crosswalk and stop line on Technology Drive.
- Study the impact of adding a traffic signal at this intersection given the concerns about driver and pedestrian safety.
- Consider shortening or removing the stone wall framing the entrance to Technology Drive to improve both pedestrian and vehicle visibility.
- Repair the west side of the sidewalk at the Technology Drive intersection to improve accessibility for all users.

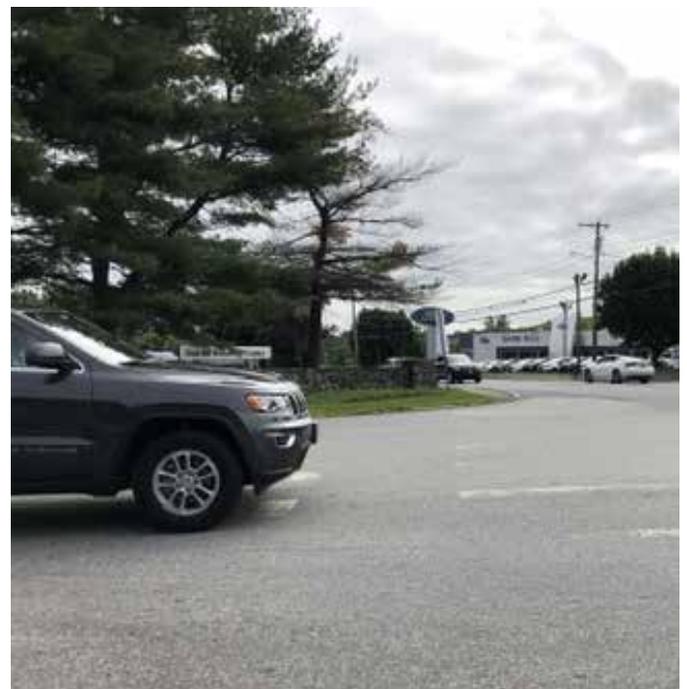
A car inches towards the faded stop line and crosswalk to see past the stone wall on the corner of Technology Drive.

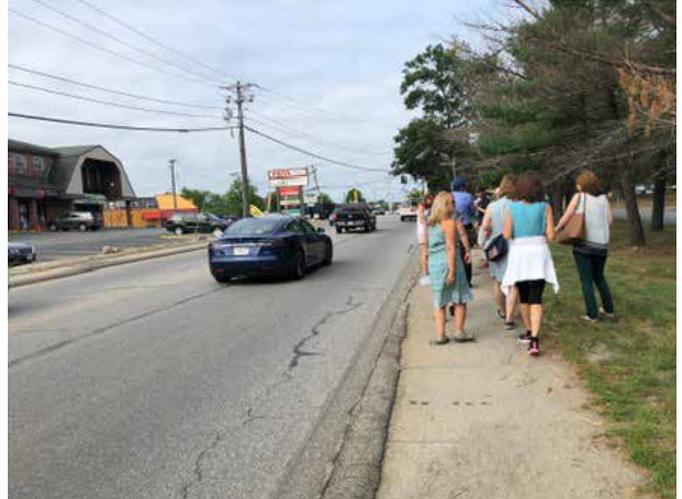
Drum Hill Road/Westford Street has an incomplete sidewalk network and no verge to safely separate pedestrians from vehicle traffic. The sidewalk is narrow and unpaved in sections along the north side of the street and severely fragmented, full of gravel, or non-existent on the south side of the street. According to city staff, the sidewalk fragmentation may be due to development projects that provide sidewalks only within their site project boundaries, which is allowed under current development guidelines. Participants experienced the breaks in the sidewalk most often at driveways and property boundaries.

People walking along Drum Hill Road/Westford Street must abut loud and fast vehicular traffic without any verge or buffer.

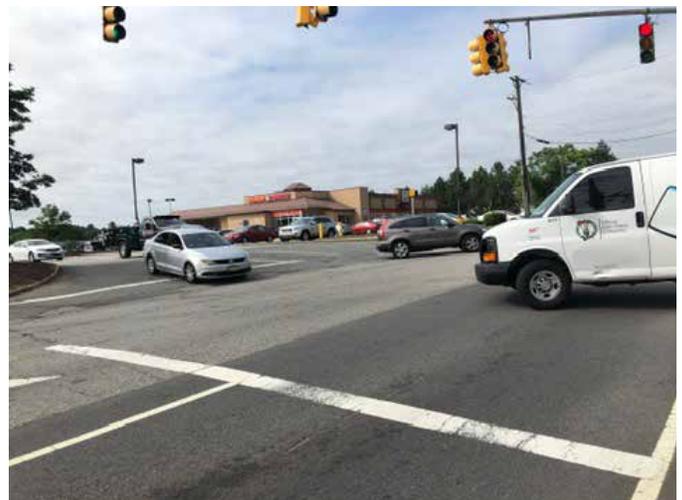
The intersection at the entrance to the Walmart retail plaza is a high traffic area with only one crosswalk on the west side of the intersection.

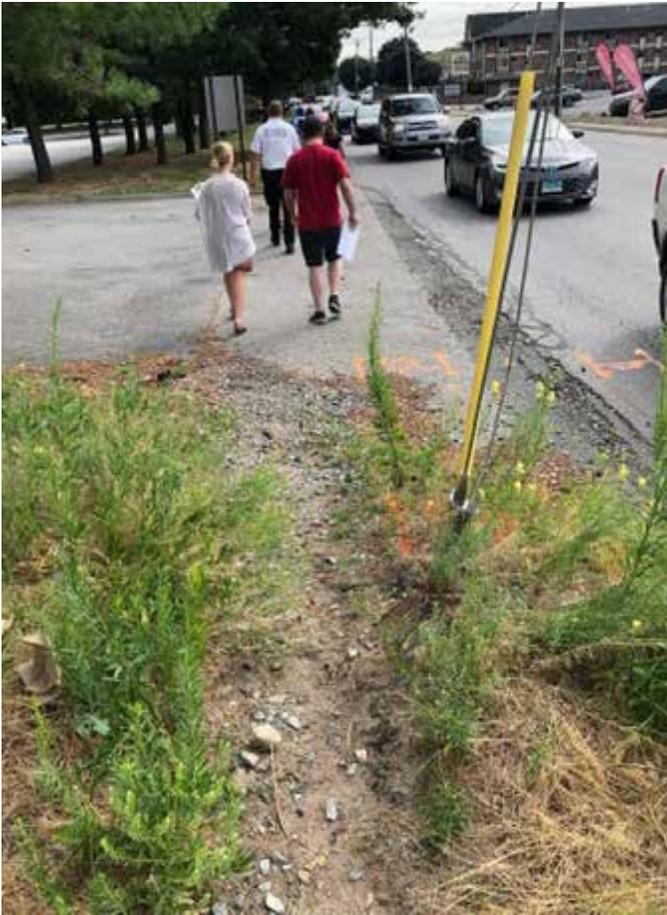
The sidewalk along Drumhill Road/Westford Street is interrupted by vegetation, rubble and other barriers for walkers.

- Review site plan requirements for development projects to ensure that property owners are held responsible not only for building and maintaining sidewalks in front their lot, but also for creating and maintaining sidewalk connections to abutting properties.

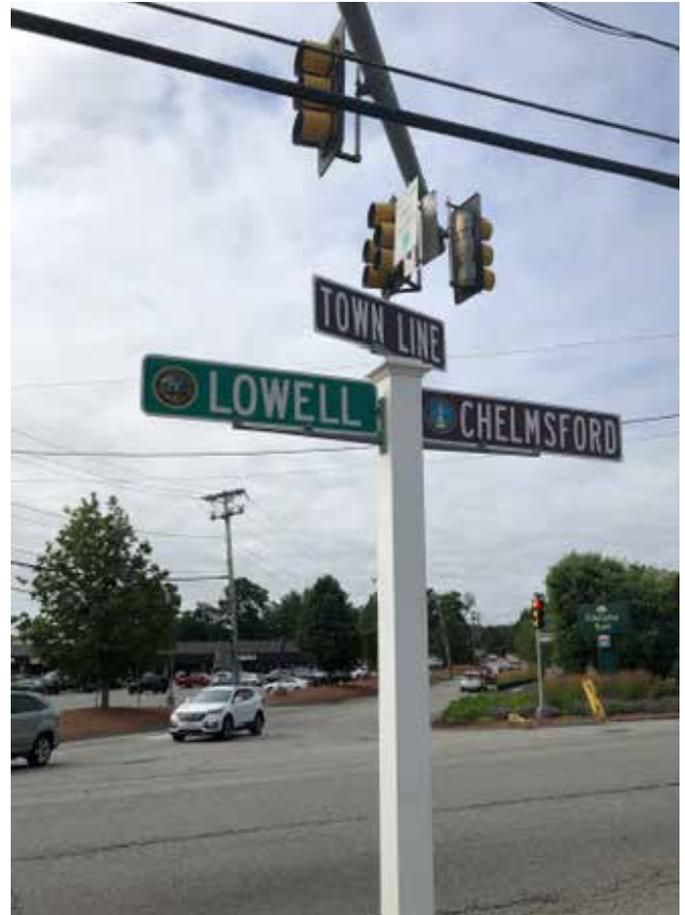
The intersection of Parkhurst Road and Drum Hill Road/Westford Street is a wide expanse of pavement with no pedestrian signal or crosswalks. There are few traffic signals along this corridor that provide a protected crossing phase for people walking. Given the fact that a traffic signal is already in place at this intersection, adding pedestrian signals would provide at least one safer option to cross the street.

The southwestern corner has an incredibly wide curb radius which facilitates fast right-turning traffic from Drum Hill Road to Parkhurst Road. The asymmetric configuration of this intersection and the fast-moving vehicle traffic make this section of Drum Hill Road/Westford Street particularly unsafe for pedestrians. In August 2015, a pedestrian was injured upon being struck by a driver at this intersection.

Drumhill Road/Westford Street intersects with Parkhurst Road and changes name at the town border between Lowell and Chelmsford.

- Add a crosswalk at the western Gulf Gas Station driveway to raise awareness of people walking across this signalized driveway.
- Trim vegetation blocking pedestrian signage.

- Redesign the intersection to reduce the amount of pavement and improve pedestrian safety. Two recommendations to consider include:
 - » Realign Parkhurst Road so that it meets Drum Hill Road at a 90-degree angle; install pedestrian signals and crosswalks.
 - » Remove signalization of the Gulf Station driveway; forbid left turns out of Gulf Station driveways; tighten southwestern curb radius to minimize pavement and narrow intersection; relocate traffic signal to spot in between Gulf Station driveways; install pedestrian signals and crosswalks.
