**Mass  
in Motion**  
Better health. It's your move.®

## *North Salem Walk Audit Salem, MA*

September 19, 2019

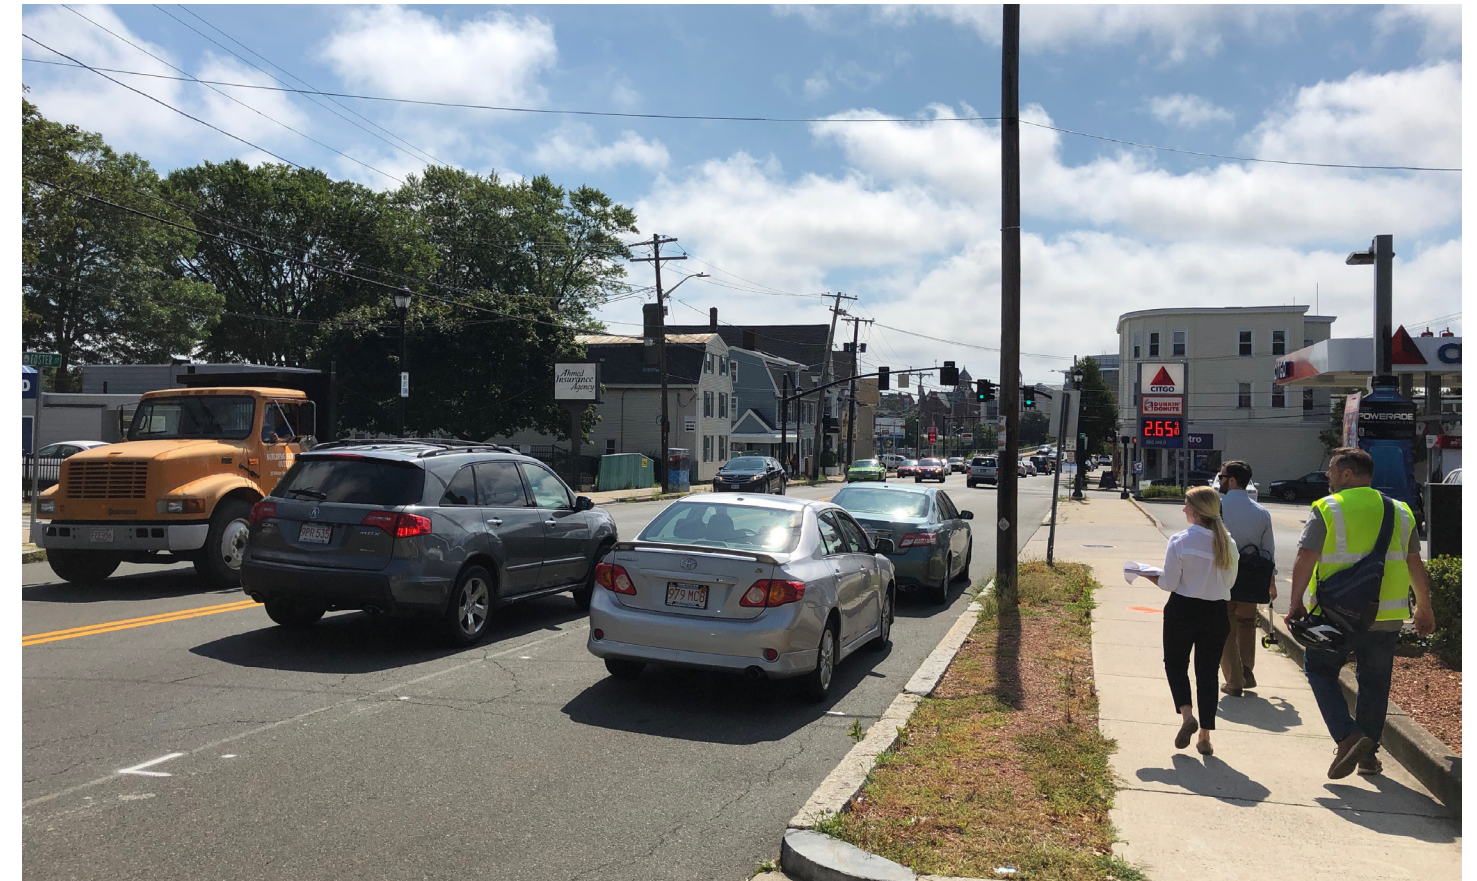
North Street has wide sidewalks and a verge to separate walkers from moving vehicles. Even so, heavy vehicle traffic and snow in winter are a couple of reasons why residents say the area is difficult to walk through.

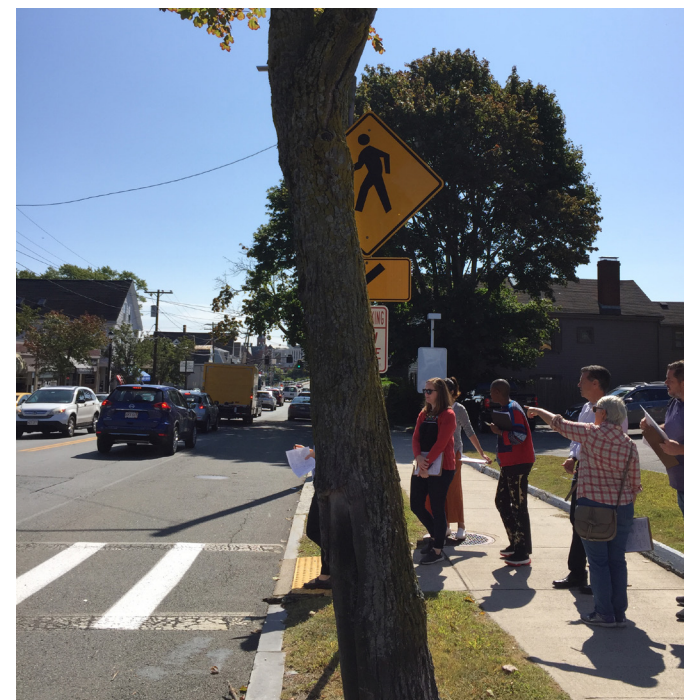
There are three crosswalks along North Street between Landwork Studios, Inc. and Orne Street to the north, which is a distance of 0.3 miles. Two of the three crosswalks are at signalized intersections (Mason Street and Orne Street) and one crosswalk is a midblock crossing with signage and no signal north of Osborne Street. The distance between the existing crosswalks exceeds the National Association of City Transportation Officials (NACTO) recommended distance of 200 feet in densely populated areas. Vehicles often park too close to the midblock crossing at Osborne Street reduces pedestrian visibility.

View of the crosswalk signage at Osborne Street is obstructed by a tree.

- e. Consider parking regulations to enhance pedestrian visibility, such as enforcement of a no parking zone within 20 feet of an intersection with a crosswalk.

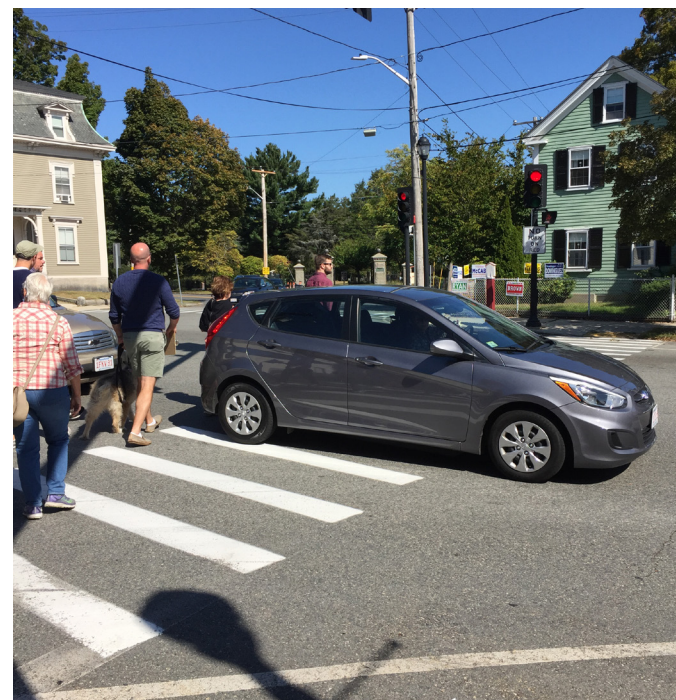
Along North Street, heavy traffic congestion means drivers do not always pay attention to walkers' right of way.

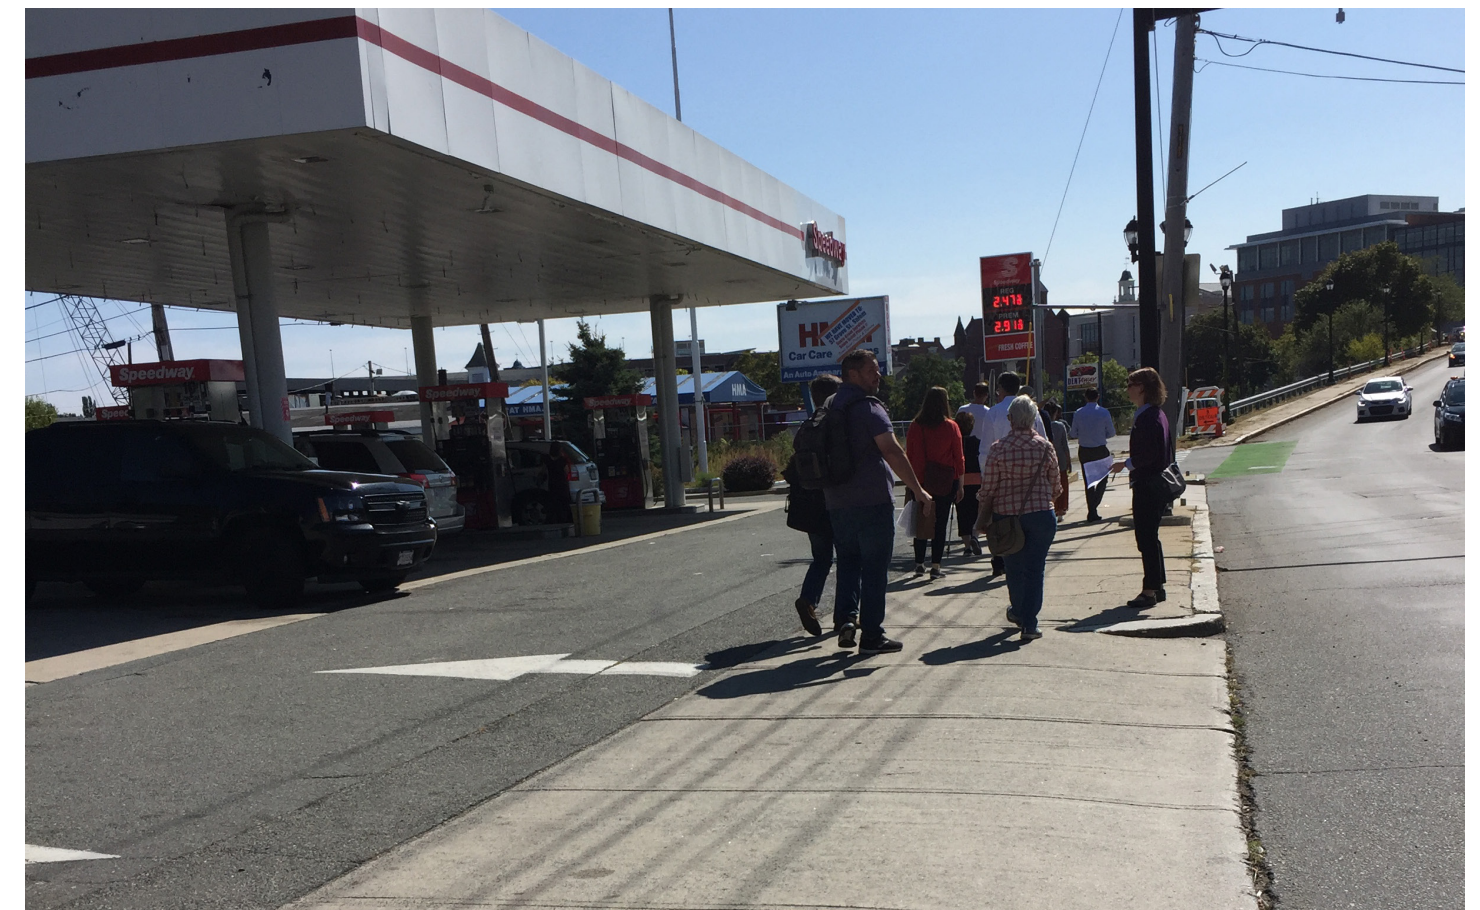
There are many business entrances on North Street that have driveways with wide curb cuts that walkers must cross when they are walking on the sidewalk. The

constant flow of traffic taking high speed, wide turns into and out of these businesses requires walkers to be extra vigilant when walking along North Street, reducing the level of comfort for people walking.

Curb cuts at the entrances to gas stations and other businesses along North Street are wide, encouraging drivers to turn at higher speeds.

5. Curb cuts: Evaluate city site plan guidelines and work with property owners (new and existing) to reduce the frequency and length of driveway curb cuts. Minimize curb radii lengths to slow turning cars. Require that sidewalk pavement material (e.g., concrete, brick) continue across driveways with a comfortable cross-slope to indicate pedestrians have priority along sidewalk length.

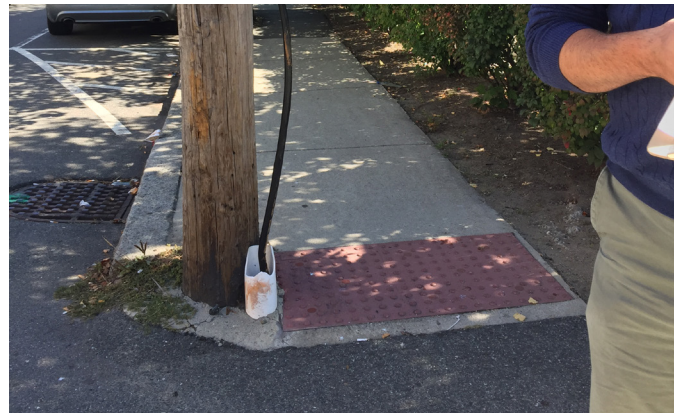
Power line poles on Mason Street obstruct the sidewalk.

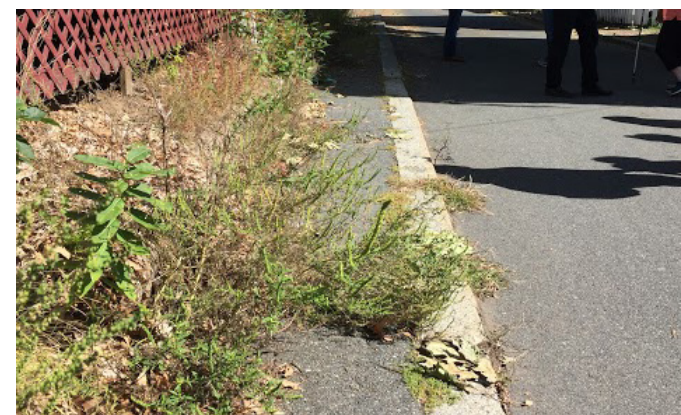
Overgrown vegetation on Randall Street is a challenge for walkers.

by the residents, the narrow sidewalks need to be addressed.

- Study the impact of ending Randall Street before it intersects with North Street through the use of bollards or some other traffic controls.
- Consider installing a crosswalk at the intersection of Randall Street and North Street to allow people to cross North Street at this location.
- Address the issues of the narrow sidewalks either by implementing a shared use street concept for the length of Randall Street, or some other re-allocation of space to provide sidewalks for users of all abilities.

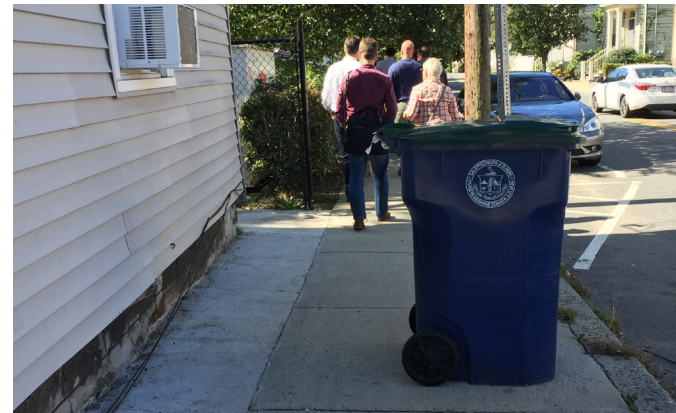
A trash bin disrupts an otherwise wide sidewalk on Mason Street.

4. Sidewalks: Evaluate city ordinances for reducing clutter of sidewalks (sandwich board signage at businesses, newspaper receptacles, etc) to ensure that they do not obstruct walk ways.

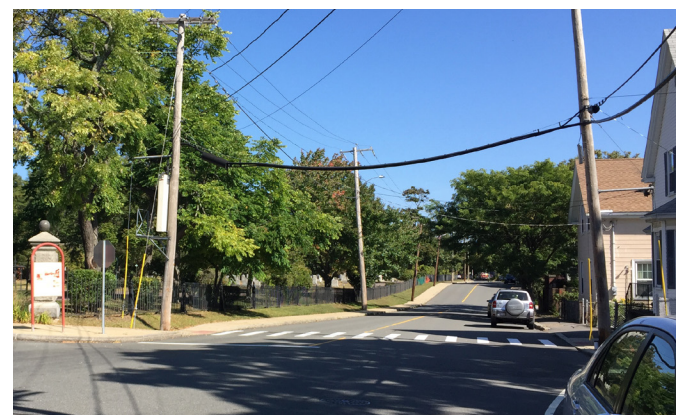
Utility poles on Orne Street block pedestrian crossing ramps.

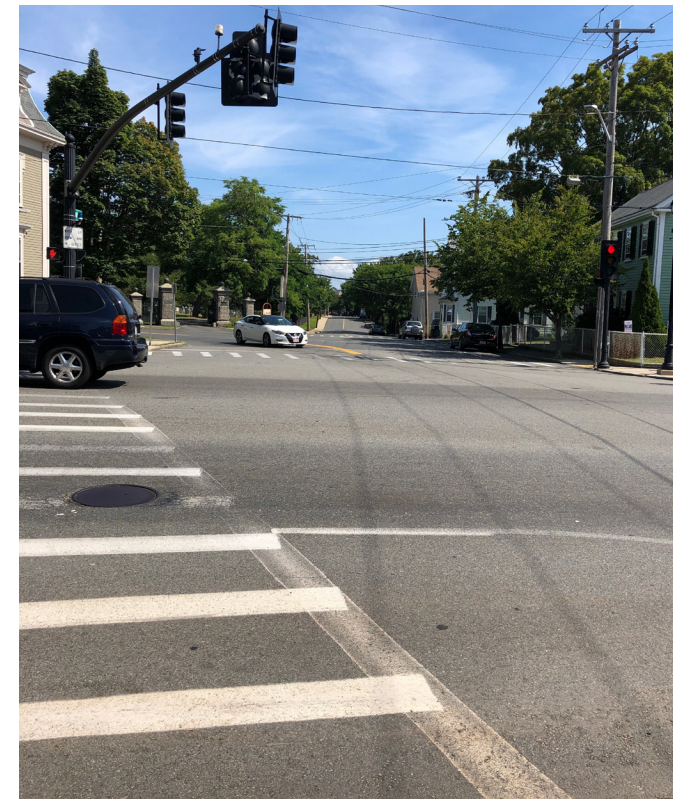
The intersection of North Street and Orne Street.

This intersection is particularly treacherous for people walking due to the long crossing distances, asymmetrical approaches, and blind corners. The intersection is signalized with an exclusive pedestrian phase, but no countdown signals. The exclusive pedestrian phase seems appropriate at this location given the vulnerable populations using this intersection. Bates Elementary School is located in the North Salem neighborhood on Liberty Hill Avenue, which can be accessed from North Street via Orne Street. The school has received Safe Routes to School infrastructure funding to improve walkability to the school campus from the surrounding residential streets, however the project scope does not extend to this intersection. Currently, parents do not let their children walk to school across North Street due to high traffic volumes, aggressive red light running, and long crossing distances.

- Study options to narrow all approaches to the intersection with the goal of shortening crossing distances for people walking. Options to consider include curb bump-outs, pedestrian refuge islands (particularly at the Orne St/Appleton St intersection), and/or narrowing travel lanes by adding bike lanes or changing lane striping layout.

- Evaluate signal timing and phasing to minimize the wait time for pedestrians to improve compliance with the WALK signal and reduce wait times for all road users.

- Install a WALK countdown signal with audible and tactile accessible pedestrian signal warnings at the intersection of Orne Street and North Street
- Install a crosswalk across Appleton Street with appropriate enhancements including curb ramps, detectable warning strips, and advance signage. Consider installing an RRFB if additional warning is needed to slow vehicular traffic.

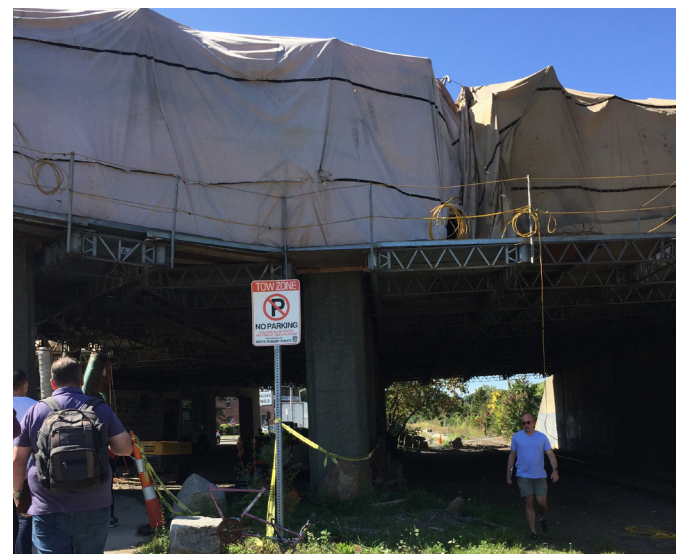
People walking to the train station from the west side of North Street could walk under the bridge without crossing North Street, but this pathway is not well-marked, well-lit or well-maintained. The North Street bridge underpass also serves as an access point to Leslie's Retreat Park. There are no sidewalks on North Street at the pedestrian park access points. Despite close proximity to North Salem, residents use their vehicles to access the park's southwest entrance where there is a larger parking lot.

The North Street bridge underpass is not well marked, lit, or maintained but still used as an access point Leslie's Retreat Park.

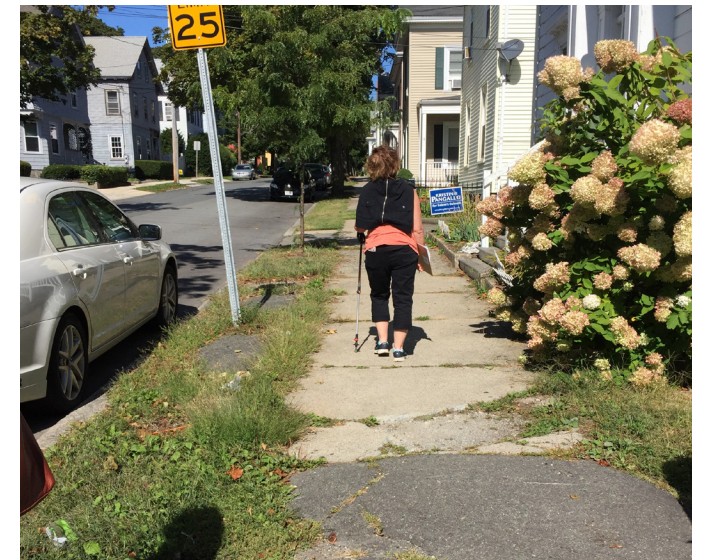
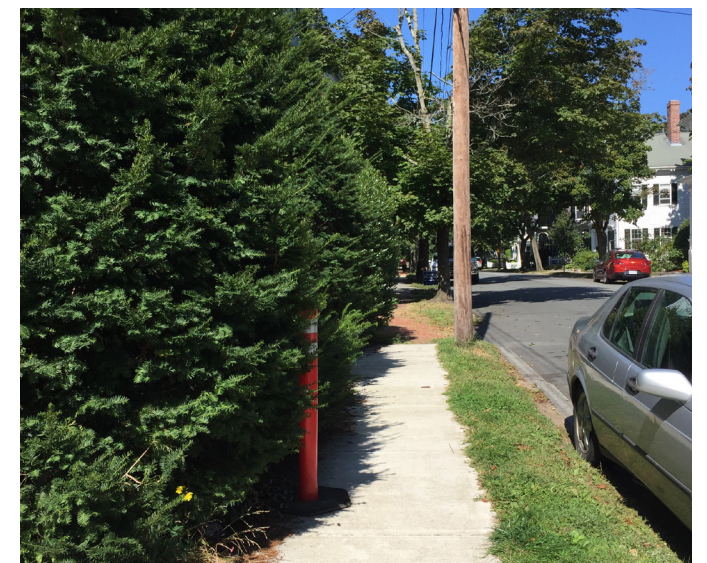
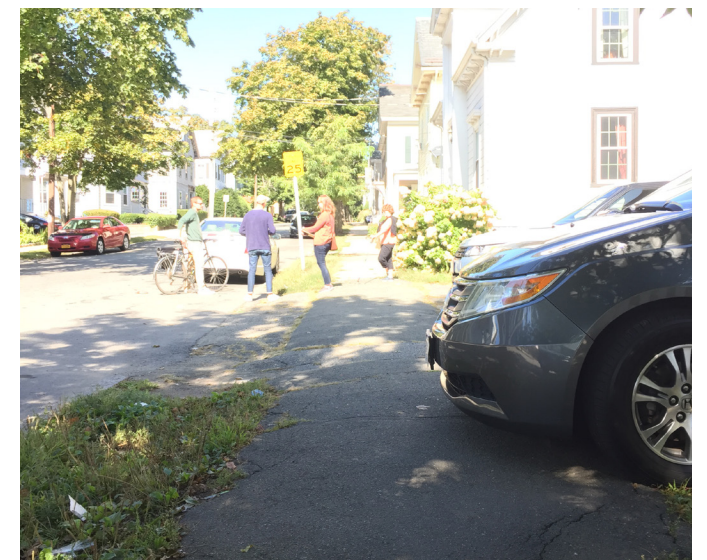
Sidewalks along Buffum Street are generally in good shape, however overgrown vegetation narrows or obstructs the sidewalk on Buffum Street at several locations. Also, the granite curbs at the sidewalk verge of Buffum are low and non-existent in some places, which leads to cars parking in the verge.

Poor walking conditions such as broken and cracked sidewalks, and obstructions like overgrown vegetation and cars parked into the sidewalk, are barriers for walkers along Buffum Street.

1. Study options to reduce the volume and speed of cars on Buffum Street including a one-way traffic pattern, speed tables, or other measures
2. Trim vegetation to improve the accessibility of sidewalks along Buffum Street
3. Standardize the height of the curb along North Street to separate discourage parking on the sidewalk and verge
4. Add a crosswalk at the intersection of Buffum Street and Randall Street
