***Rebecca Johnson Elementary School
Walk Audit
Springfield, MA***

March 4, 2015

Purpose and Goals of the Walk Audit

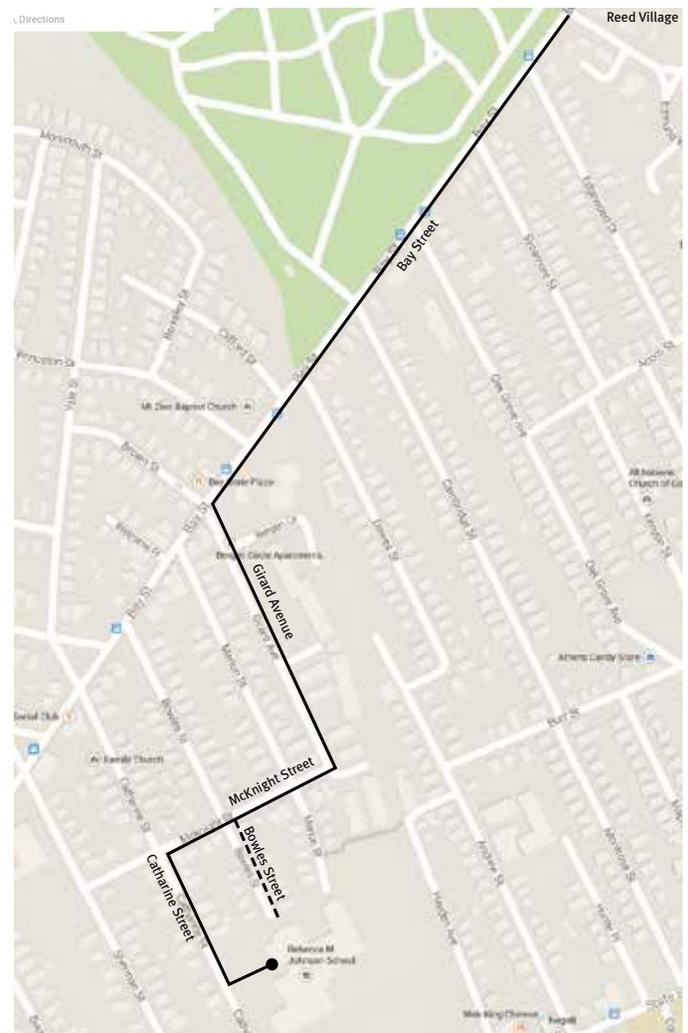
Map of proposed walking school bus route from Reed Village

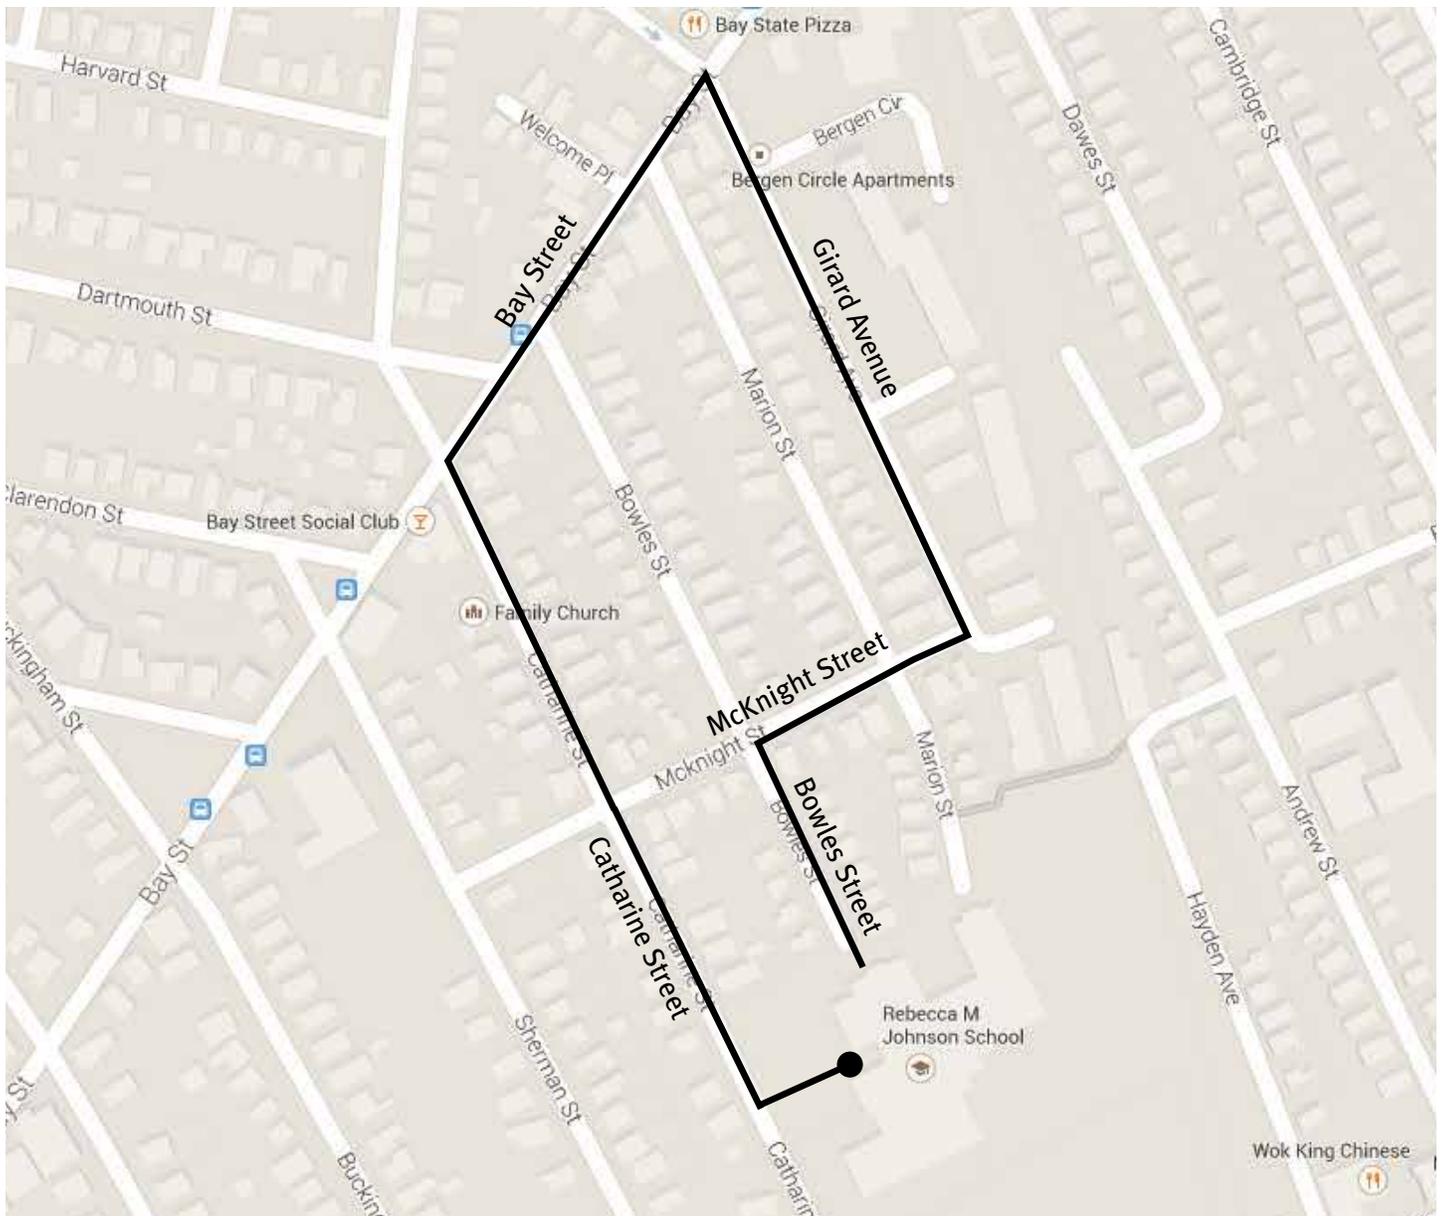
Map of walk audit route

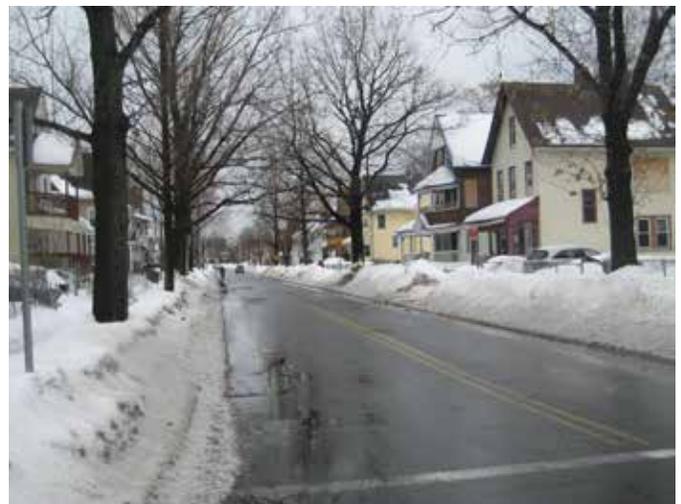
Sidewalks approximately 4 to 5 feet in width run along both sides of Catharine Street between Bay and State Streets. Narrow green, grassy strips (called a verge) separate the sidewalks from the curbs along Catharine Street that provide some separation between fast-moving traffic and people walking. Trees line both sides of the street, which provide shade and further define the edge of the street. The condition of the sidewalks was hard to determine given the amount of snow on the ground.

View down Catharine Street

The street crossings across Catharine Street had marked crosswalks with minimal striping, except at the State Street intersection where the crosswalks are enhanced with a red, stamped asphalt brick pattern. The crosswalks at the entrance and exit drives at Rebecca Johnson had no curb ramps and terminate in driveways rather than leading to the sidewalks. The crosswalks at the Catharine/McKnight Streets intersection have curb ramps, but are missing detectable warning strips.

School zone signage is missing along Catharine Street and pedestrian crossing signs appear only at the crosswalk adjacent to the school exit drive. There are no signs placed in advance of the crosswalk to warn of pedestrians crossing. On-street parking is prohibited south of the McKnight Street intersection.

1. Slow traffic down on Catharine Street
 - Place in-street pedestrian signs in the crosswalks adjacent to the entrance and exit drives to Rebecca Johnson (short-term)

- Install raised crosswalk(s) across Catharine Street near entrance and exit drives to Rebecca Johnson (long-term)
 - Work with law enforcement to continue monitoring speed and enforcing speed limits near the school

2. Improve visibility of street crossings
 - Consider relocating crosswalks adjacent to the entrance drives away from driveways
 - Install curb ramps and detectable warning strips

- Repaint crosswalks using a zebra or continental design
3. Delineate school zone
 - Install school zone signs with 20 mph speed limits in highly visible locations at all approaches to the school

- Consider painting SCHOOL ZONE pavement markings on Catharine Street
 - Install wayfinding signs to Rebecca Johnson from major intersections at Catharine/State and Catharine/Bay Streets for people walking and driving.

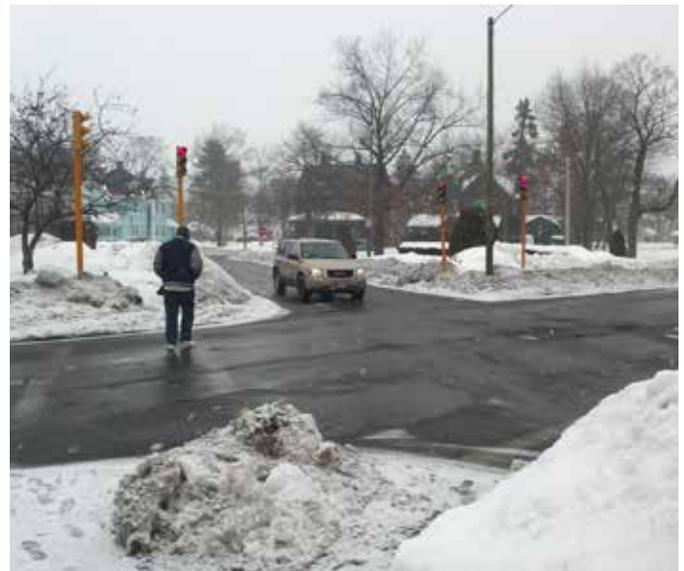
The Catharine Street/Bay Street intersection is a dangerous crossing point for students walking to Rebecca Johnson. The angle at which the streets cross poses a challenge, lengthening crossing distances and limiting visibility. There is a crossing guard posted at this intersection at arrival and dismissal times, which improves student safety. The intersection is signalized, but there are no pedestrian signals and therefore no protected pedestrian signal phase. Marked crosswalks exist on three of the four legs of the intersection, but not on the side that provides the most direct route for students traveling from northeast of the school. The crosswalks have only minimal pavement markings.

Catharine/Bay intersection has no pedestrian signals

1. Improve visibility of street crossings
 - Repaint crosswalks using a zebra or continental design and mark all four legs
 - Install missing curb ramp and detectable warning strips
2. Provide protected pedestrian crossing phase
 - Install pedestrian signals on all legs of the intersection
 - Consider concurrent phase with an automatic WALK signal

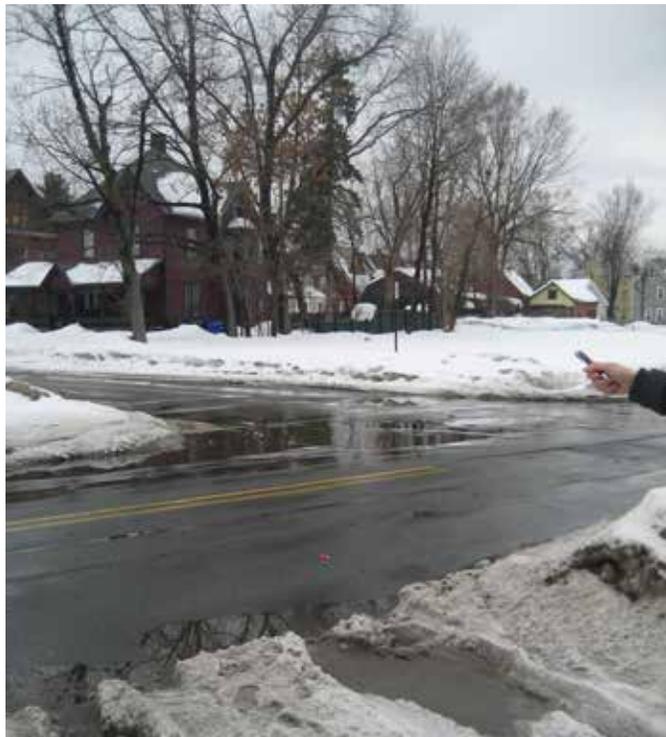
Students cross Bay Street at Dartmouth Street despite the fact that there is no marked crosswalk. A crossing guard is posted at this intersection to improve safety, but students crossing at times other than arrival and dismissal have no protection.

The Bay/Dartmouth intersection has no marked crosswalk, but students and other pedestrians cross here frequently

1. Improve safety of pedestrians crossing from the north side of Bay Street to the south side at the Catharine Street and Dartmouth Street intersections
 - Study safety implications of painting a crosswalk at the Dartmouth and Bay Street intersection; paint crosswalk if deemed appropriate
 - Repaint crosswalks using a zebra or continental design along Bay Street at the Bowles Street, Marion Street and Girard Avenue intersections
2. Improve drainage along Bay Street
 - Evaluate effectiveness of storm drains to remove water from Bay Street; any major redesign should address known drainage issues (long-term)

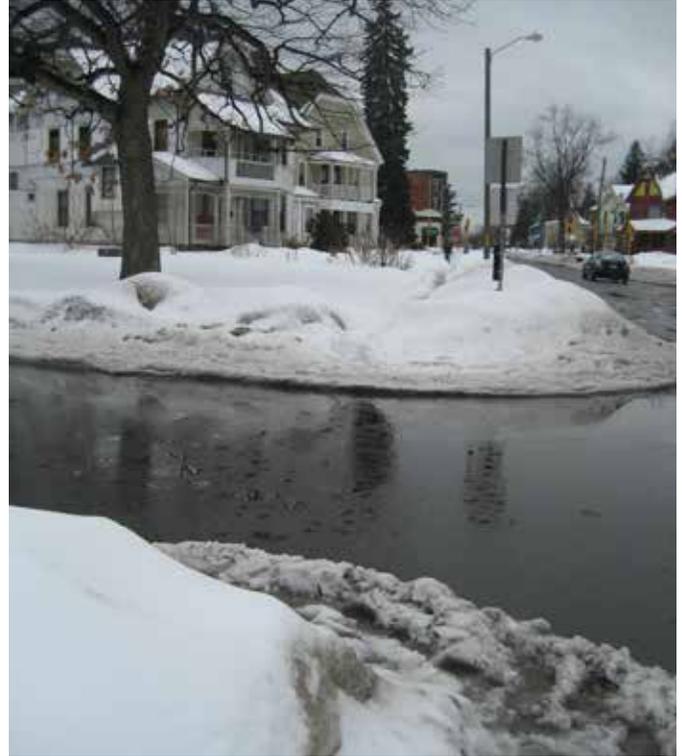
Bay Street was flooded where drainage structures were blocked by snow.

Bay Street has significant drainage issues. While the snow depths were higher than average, water was ponding across intersections making them impassable for pedestrians. Participants found themselves in the middle of the road to avoid deep puddles. Storm drains were either obstructed or ineffective in moving water off the streets.

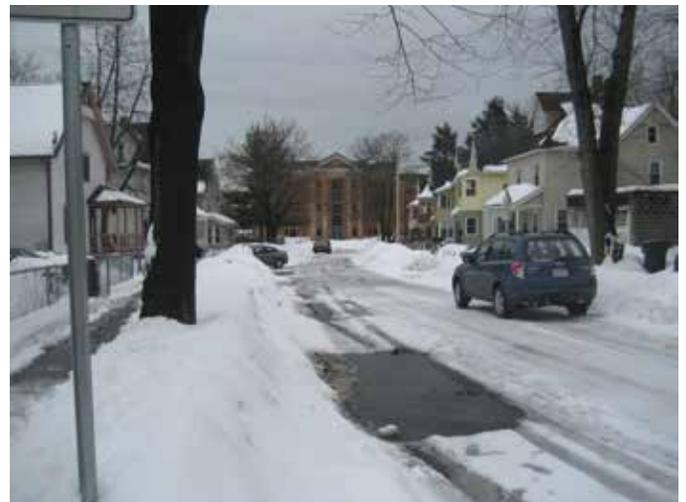
Both Bowles Street and Marion Street are neighborhood residential streets that terminate at Rebecca Johnson’s campus. There are sidewalks on both sides of each street. As described above, parents dropping off and picking up students use these streets to access the school. Neither street was designed as a cul de sac and therefore both have limited space to accommodate vehicles turning around. Homeowners on both streets are often parked in by parents waiting for school to be dismissed.

View down Marion Street to Rebecca Johnson

1. Improve safety at the Bowles Street and Marion Street dismissal point
 - Consider prohibiting pick up and drop off at the end of Bowles and Marion Streets; close streets to traffic during arrival and dismissal except for residents
 - Consider making McKnight Street the parent pick up point for students dismissed at the Bowles Street and Marion Street doors
 - Work with the city department of public works and neighborhood residents to formalize pick up procedures along McKnight Street to minimize traffic impacts
 - Adjust staffing to provide student supervision on Bowles and Marion Streets to pick up point on McKnight Street

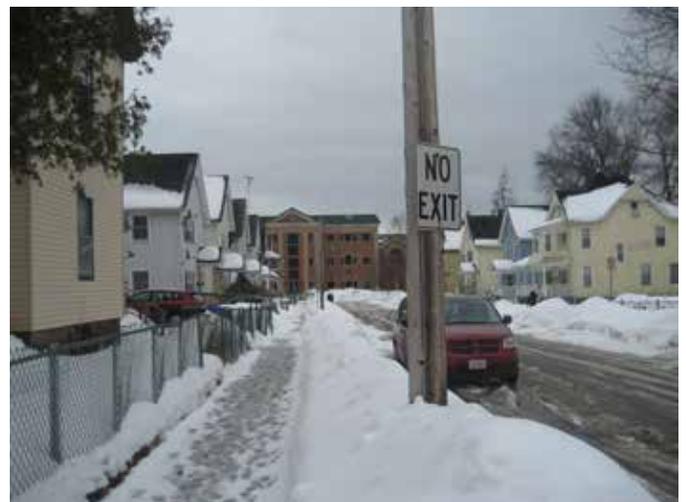
View down Bowles Street to Rebecca Johnson

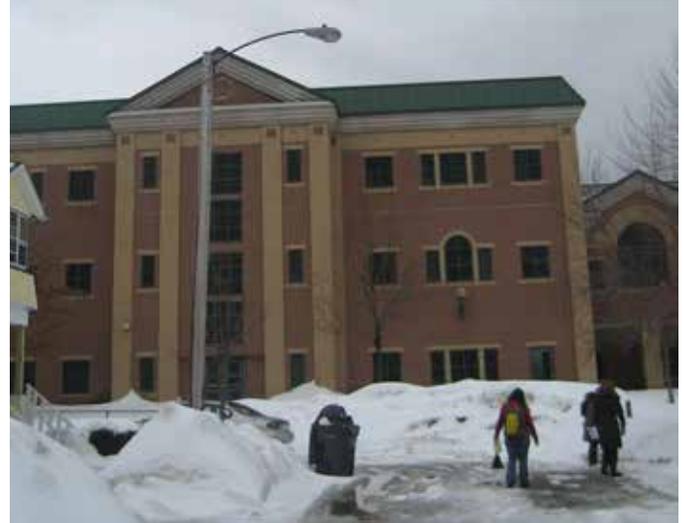
Snow removal on these streets was a primary concern. City plows had pushed snow into towering piles up against the school property at the base of both Bowles and Marion Streets. The snow obstructed pathways and limited the visibility of students coming out of school. Students were forced to walk single file in some cases around these mounds to the street. Snow removal responsibilities were complicated due to the overlapping property boundaries of the school, street right-of-way, and the adjacent park. School staff participating in the audit suggested that the school staff needs to improve snow removal on its property in this area.

Snow piled in front of the school entrances at the end of Bowles Street

2. Prioritize snow removal along Bowles and Marion Streets
 - Resolve property boundary issues and determine responsibilities for snow removal
 - Ensure that walks and stairs on Rebecca Johnson property along the north side of the school are cleared of snow

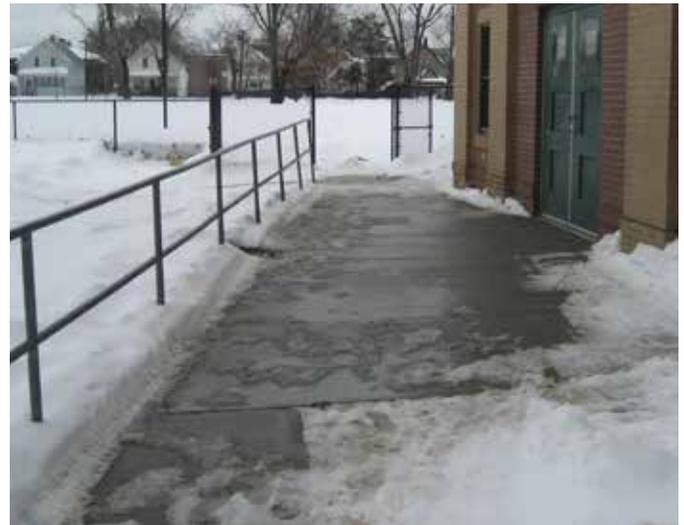
School walkways were not cleared near entrance doors along the northern side of the school

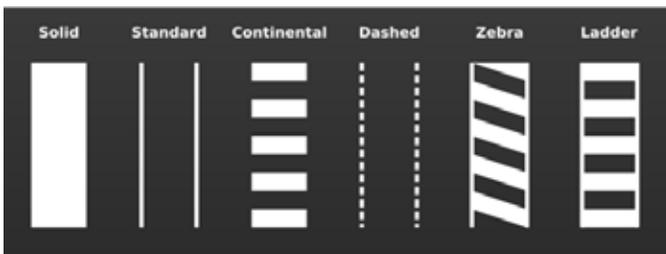
Crosswalks can be painted in a variety of ways, some of which are more effective in warning drivers of pedestrians. Crosswalks are usually accompanied with stop lines. These lines act as the legally mandated stopping point for vehicles, and discourage drivers from stopping in the middle of the crosswalk.

Crosswalk patterns
Source: USFHA

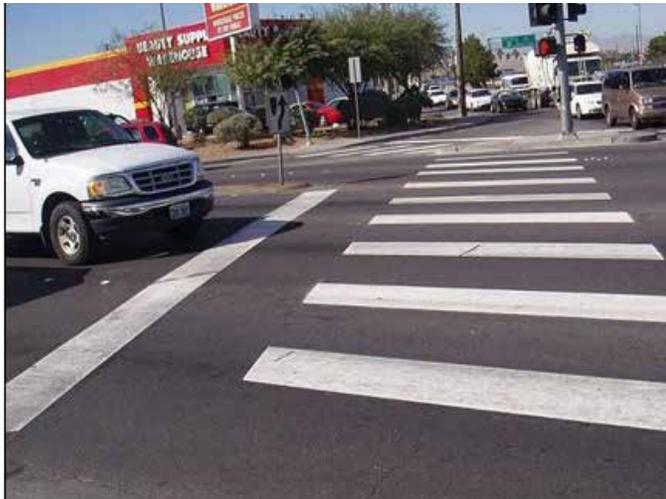
Crosswalk and stop line
Source: http://safety.fhwa.dot.gov/ped_bike/tools_solve/ped_scdproj/sys_impact_rpt/images/fig16.jpg

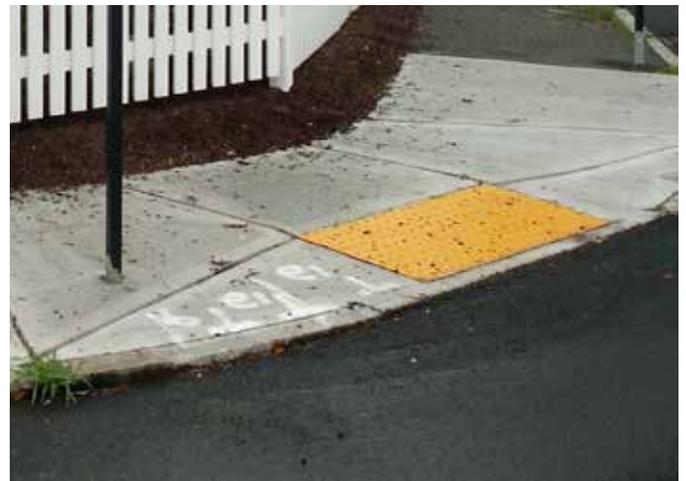
Curb ramps provide access from the sidewalk to the street for people using wheel chairs and strollers. They are most commonly found at intersections. While curb ramps have improved access for wheelchair-bound people, they are problematic for visually impaired people who use the curb as an indication of the side of the street. Detectable warning strips, a distinctive surface pattern of domes detectable by cane or underfoot, are now used to alert people with vision impairments of their approach to streets and hazardous drop-offs.

Curb ramp and detectable warning strip in Woburn, MA

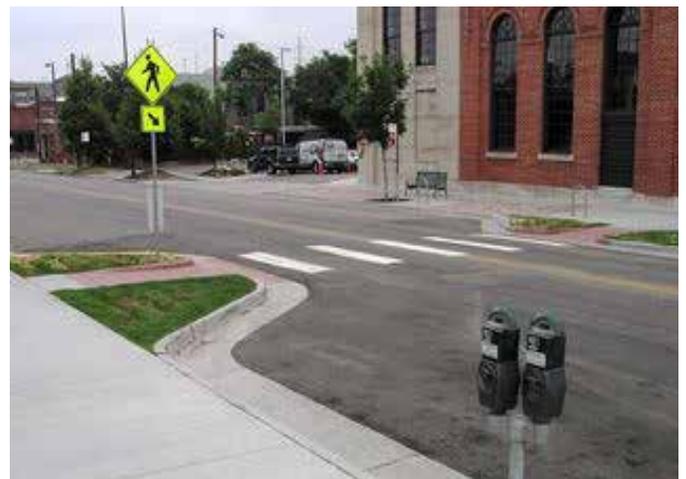
A sidewalk extension into the street (into the parking lane) shortens crossing distance, increases visibility for walkers and encourages eye contact between drivers and walkers.

Curb extensions are often associated with mid-block crossings

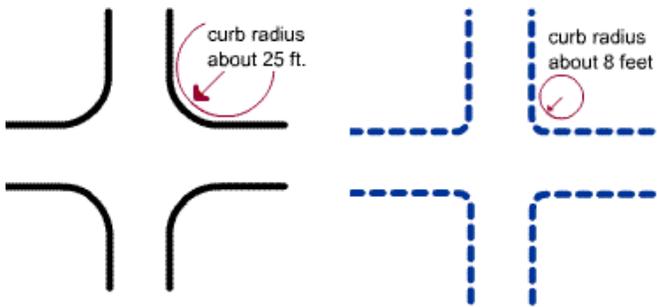
A longer curb radius (on the left in figure below) allows vehicles to turn more quickly and creates longer crossing distance for pedestrians. A shorter curb radius (on the right in the figure below) slows turning speeds and provides pedestrians shorter crossing distances.

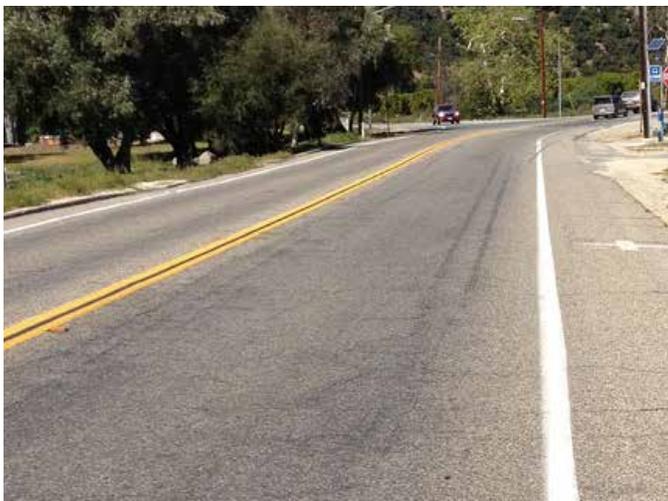
A fog line is a solid white line painted along the roadside curb that defines the driving lane and narrows the driver's perspective. Fog lines are most often used in suburban and rural locations, but may be appropriate in some urban conditions.

Fog lines delineate the vehicular driving zone on wide roadways.

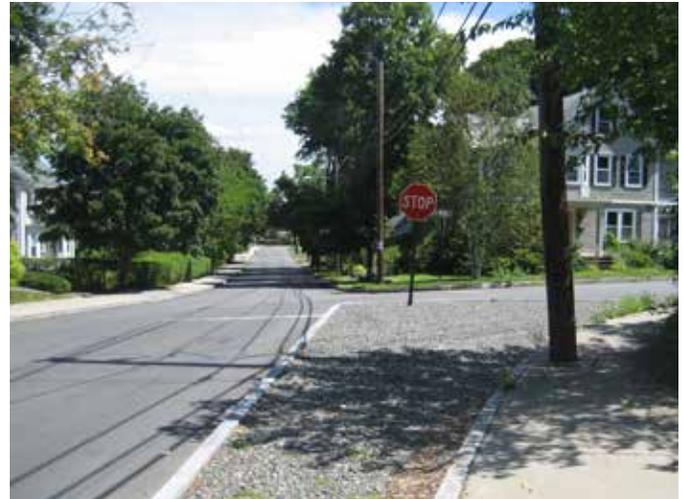
There are two excellent examples of the shortening of curb radii in Woburn, MA. The first (A) is a low-cost solution using a gravel-filled zone between the original curb line and the newly established road edge. The second is a higher-cost solution using grass and trees and extending the sidewalks to the new curb. Both work to slow traffic.

(A) Gravel-filled curb extension

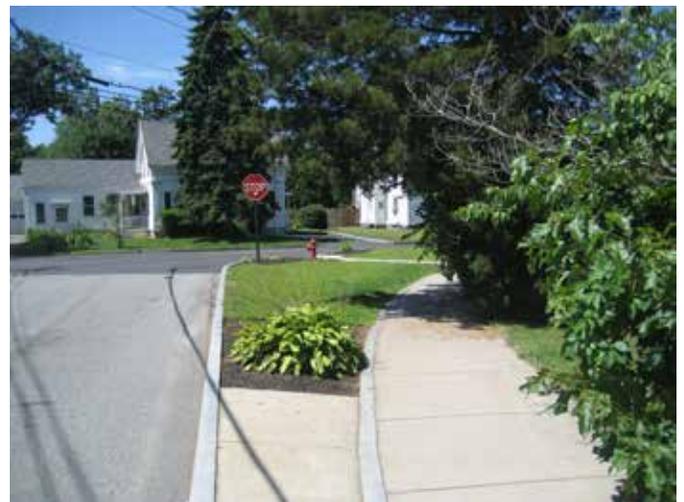
(B) Grass, trees and extended sidewalk in curb extension

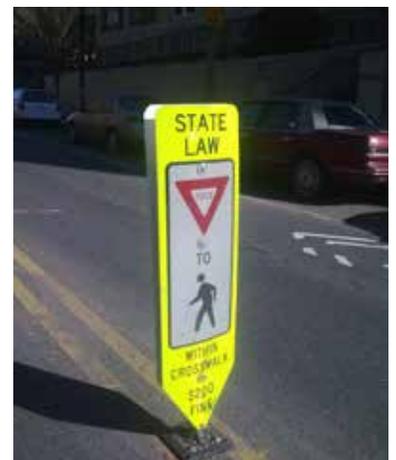
In-street pedestrian crossing signs are used at the road centerline within crosswalks to increase driver awareness of pedestrians in the area. These signs are a relatively low-cost, highly effective tool in slowing traffic by the narrowing travel lanes. They are popular with road maintenance departments since they can be easily moved for snow removal.

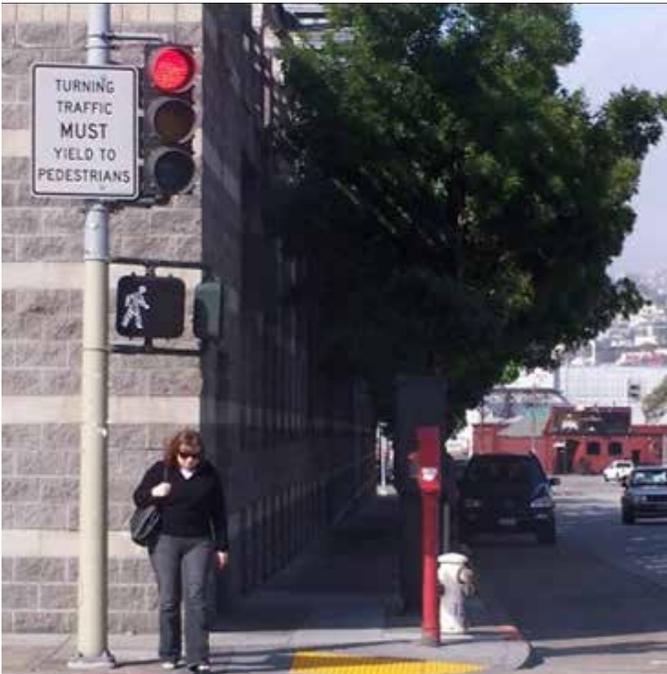
A leading pedestrian interval gives pedestrians an advance walk signal before motorists get a green signal, giving the pedestrian several seconds to start walking in the crosswalk before a concurrent signal is provided to vehicles. This makes pedestrians more visible to motorists and motorists more likely to yield to them. Typical LPI settings provide 3 to 6 seconds of advance walk time.
